THE PERILS OF THE PARAPET CAP

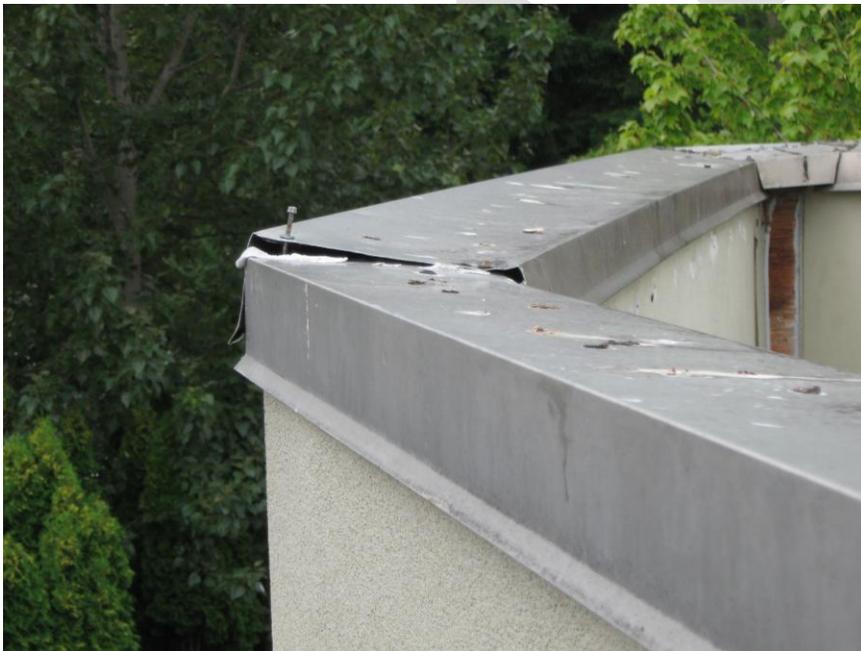
Photo 1 shows the parapet condition when the stucco contractor was called to the project to explain why his stucco system wasn't performing properly. Really?

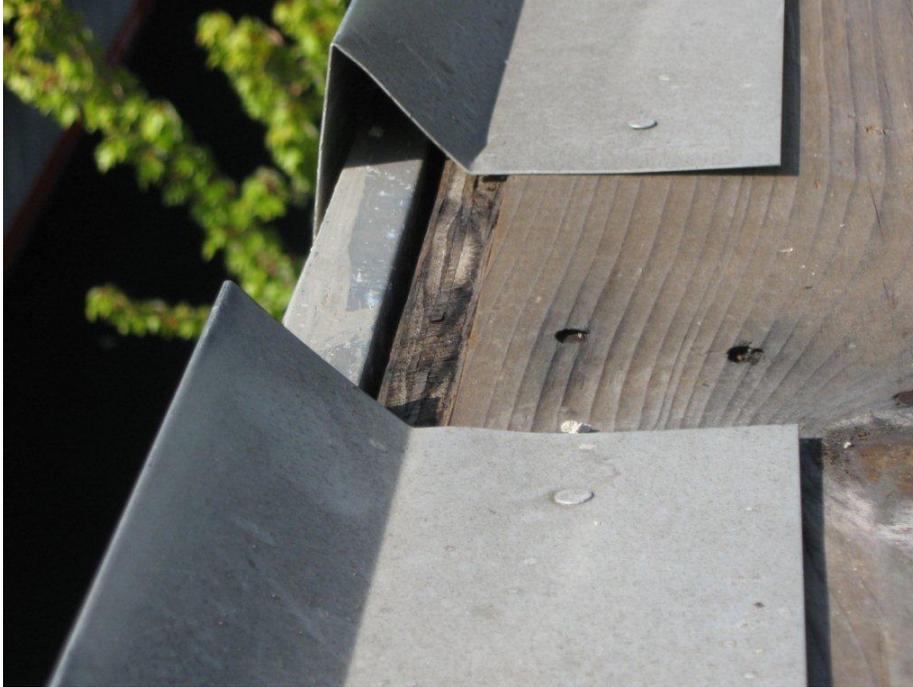
Photo 2

Photo2 below shows the condition of the head of wall when the parapet cap was removed. Note the condition of the wood and, of course, the absence of flexible flashings. The wood was not rotted because the water would drain down into the wall and would have somewhat of an opportunity to dry. The parapet cap clips are meant to hold the cap in place but at some point this cap became dislodged from the clips. The solution, as you can see in photo 1 was to nail the cap to the head of wall.

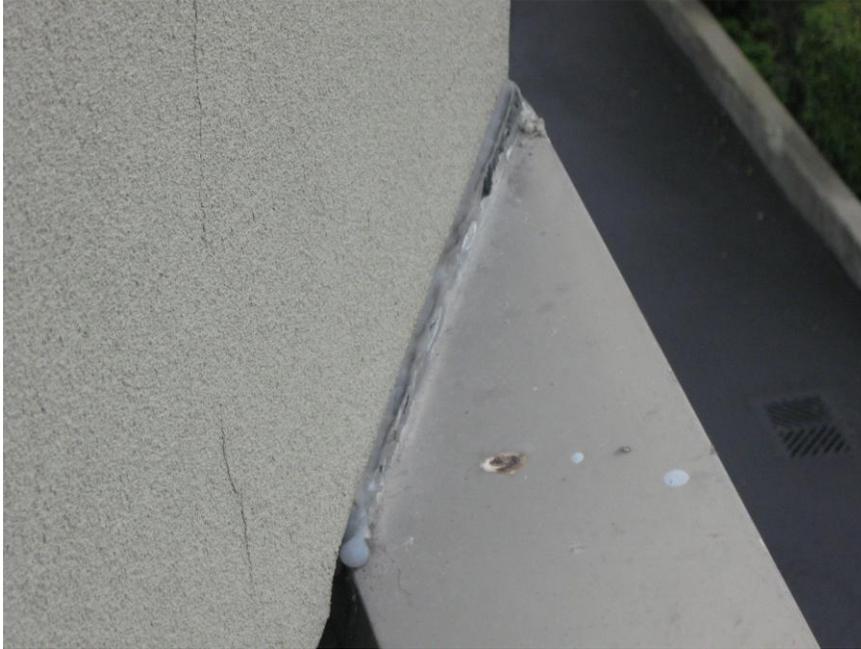
Photo 4

As you can see in photo 4 the maintenance crew was diligent in caulking the intersections of the flashing to the stucco. Evidently the term “saddle flashing” meant nothing to those that either designed or fabricated the cap.

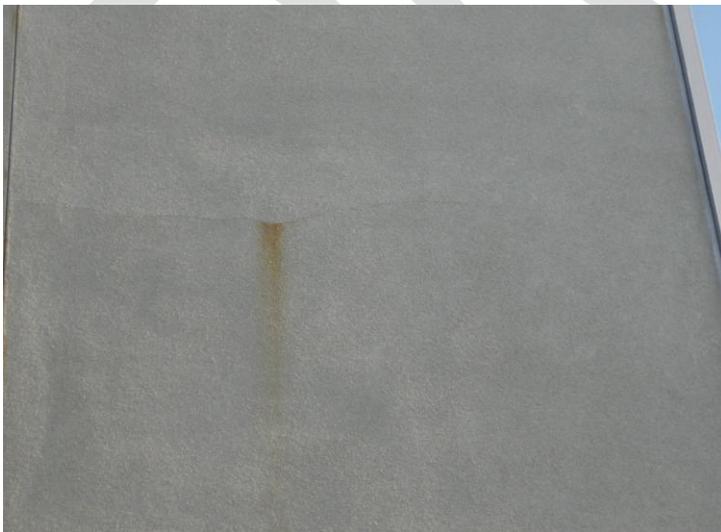
Photo 5

What would you say if you saw the condition in photo 5 on your building? Some would say that the stucco failed and allowed sufficient water to enter through the crack to the extent that rusting of the lath or accessories occurred.

In reality what has occurred is that a short distance above this crack was the parapet cap. The cap was in such poor condition that during prolonged periods of wind driven rain, water was forced under the parapet cap where it concentrated and began running down between the WRB and the back side of the stucco. The amount of water intrusion was so great, remember this is Washington, that the system was unable to properly drain or allow for periods of drying, and consequently rusting began to occur. The source of water intrusion was not the crack, the crack was a source of expulsion. The rusty water clearly indicates that the rust was occurring above the crack and then being flushed out of the crack.

Again, was the rust caused by a failure of improper accessories or poor galvanizing or...? Again I would contend that the cause was an improperly installed or maintained parapet cap that allowed concentrations of water into the assembly beyond the designed capabilities of the stucco assembly elements. Had the parapet performed properly and prevented water intrusion the paper would have never failed, the rusting would have never occurred, the crack, which likely occurred from frozen water behind the stucco, would not have formed and the stucco contractor would not have wasted his or her time and money defending the installation or components.
